Field Service Bulletin No. 15

Revised August 2008

**Alert and Handling Precautions -
 SBE 37 MicroCATs and SBE 49 FastCATs with Plastic Housing Option**

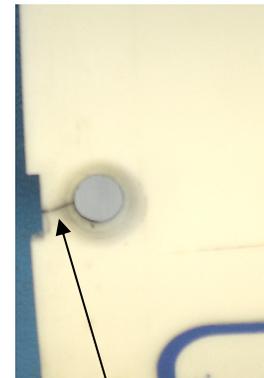
- If the ink test reveals cracking of the housing only on the **battery end cap side of the screw hole**, the MicroCAT may be deployed / redeployed as required. However, carefully adhere to the **torque specification of 15 in-lbs for the battery end cap retaining screws**. Return the MicroCAT to Sea-Bird at your earliest convenience for installation of a new housing under our standard warranty policy.
- Over-torquing the screws can cause cracking on the **electronics side of the screw hole (away from the end cap)**; this can create a leak path past the O-rings. If the ink test reveals cracking of the housing on the **electronics side of the screw hole, do not deploy/redeploy the MicroCAT, as there is a high probability of flooding** of the MicroCAT. Return the MicroCAT to Sea-Bird for installation of a new housing under our standard warranty policy.

Example crack, **battery end cap side only** (ink applied to crack to illustrate)

- If you observe a **crack only on the end cap side** of the battery end cap screw hole, you can continue to deploy the instrument, but carefully follow the torque specification. We recommend that you return the instrument to Sea-Bird for installation of a **new housing** under warranty, **when convenient** (i.e., when sending it in for calibration or other repairs).

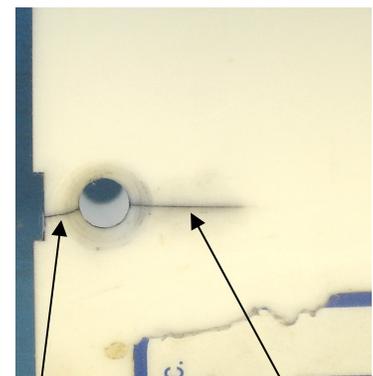
Example cracks **battery end cap side and electronics side** (ink applied to cracks to illustrate)

- If you observe a **crack on the electronics side** of the battery end cap screw hole, **do not deploy / redeploy** the instrument. Return the instrument to Sea-Bird for installation of a **new housing** under warranty.

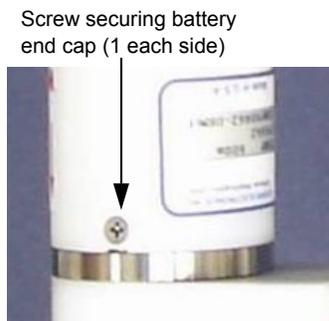
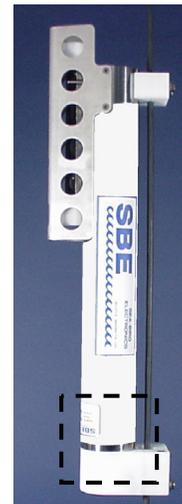
Detail - Battery end cap
SBE 37-SM, 37-SMP,
37-IM, 37-IMP

- The **SBE 37-SM, -SMP, -IM, and -IMP battery end cap** is retained by two screws through the side of the housing. Particularly in a cold environment, where plastic is more brittle, the potential for developing a crack around the screw hole(s) is greater for the plastic housing than for the titanium housing. Observe the following precautions –
 - When removing the end cap (to replace batteries and/or access electronics), avoid any impact in this area of the housing.
 - When reinstalling the end cap, do not use excess torque on the screws. Sea-Bird recommends tightening the screws to **15 inch-lbs**. Alternatively, tighten finger-tight, and then turn each screw an additional 45 degrees.

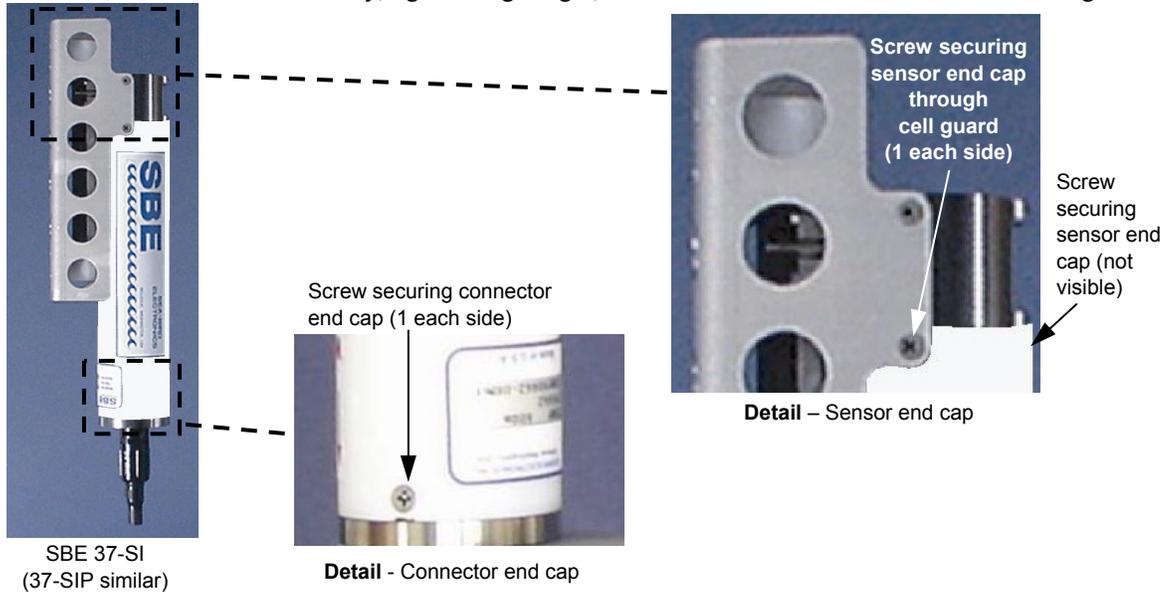
- The **SBE 37-SI and -SIP connector and sensor end caps** are retained by screws through the side of the housing (the conductivity cell guard is also secured to the sensor end cap). The screw holes are close to the end of the housing. Particularly in a cold environment, where plastic is more brittle, the potential for developing a crack around the screw hole(s) is greater for the plastic housing than for the titanium housing. Observe the following precautions –

- When removing end caps (to access electronics), avoid any impact in this area of the housing.
- When reinstalling end caps, do not use excess torque on the screws. Sea-Bird recommends tightening the screws to **15 inch-lbs**. Alternatively, tighten finger-tight, and then turn each screw an additional 45 degrees.

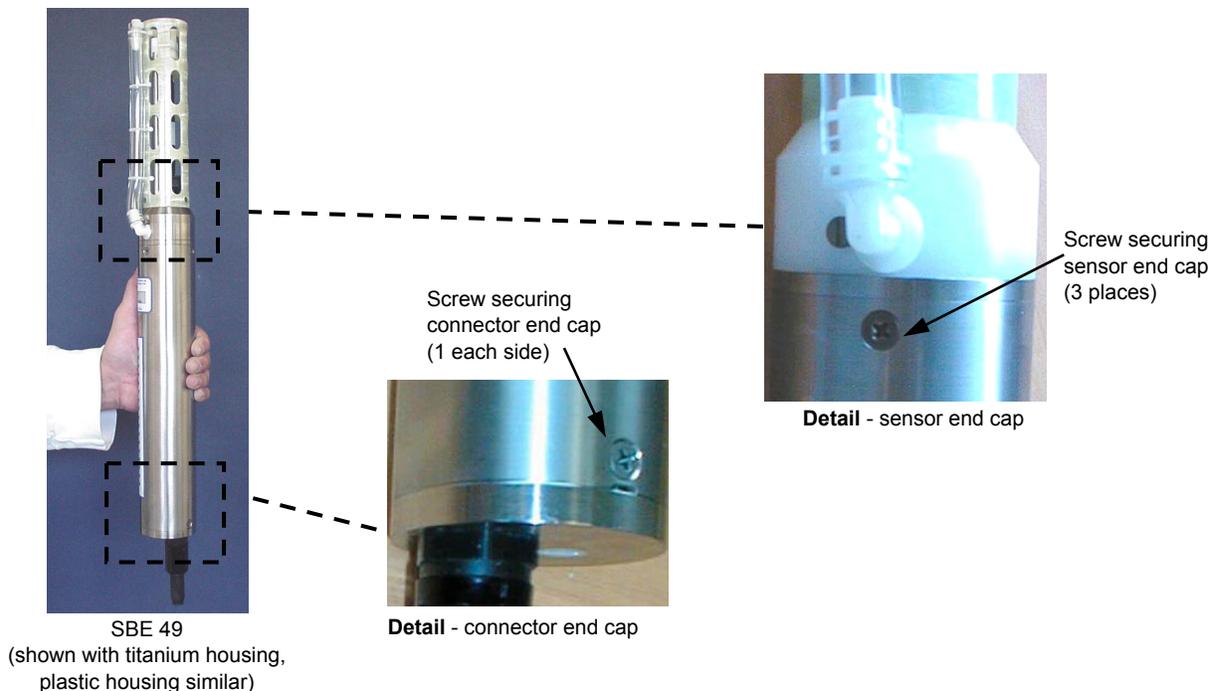
- The **SBE 49 connector and sensor end caps** are retained by screws through the side of the housing. The screw holes are close to the end of the housing. Particularly in a cold environment, where plastic is more brittle, the potential for developing a crack around the screw hole(s) is greater for the plastic housing than for the titanium housing. Observe the following precautions –

- When removing end caps (to access electronics), avoid any impact in this area of the housing.
- When reinstalling end caps, do not use excess torque on the screws. Sea-Bird recommends tightening the screws to **15 inch-lbs**. Alternatively, tighten finger-tight, and then turn each screw an additional 45 degrees.
