Equipment Affected

This field service bulletin applies to the following instruments:

- SBE 39plus units with firmware version 4.3.0 and below.
- SBE 39plus-IM units with firmware version 4.5.0 and below

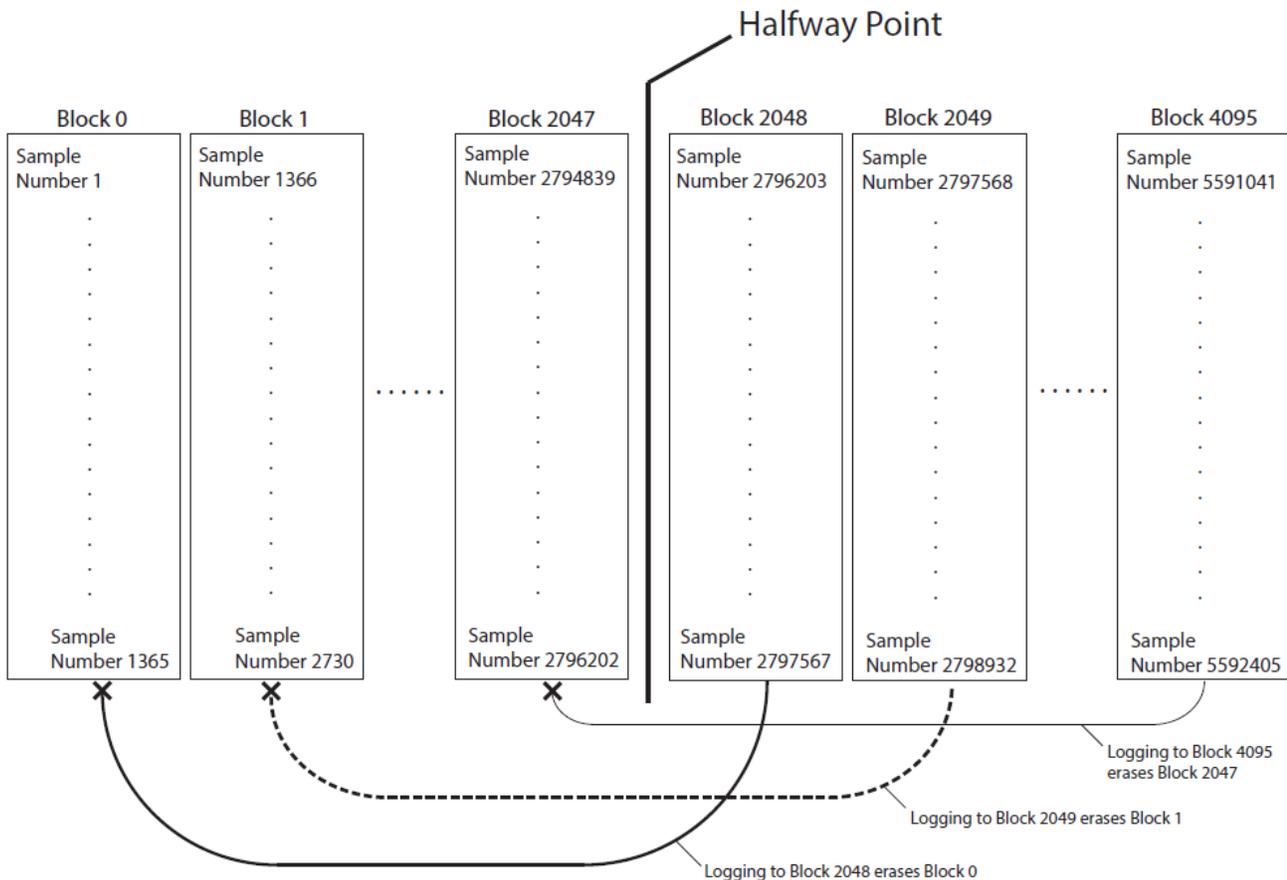
The original 39plus/39plus-IM firmware will begin erasing data after filling half of the internal memory. **Upon reaching the halfway point in the memory, the 39plus will sequentially erase one block of samples for every new block started, where one block consists of approximately 1365 samples when recording temperature, pressure, and time, and 2340 samples if recording Temperature and time only.** The diagram below demonstrates how blocks of samples are erased for a 39plus recording temperature, pressure, and time:

1. The 39plus sample pointer reaches the halfway point (sample number 2796202)
2. It begins writing data to Block 2048 (starting sample number 2796203). Block 0 is erased (samples 1 – 1365)
3. If the sample counter reaches Block 2049 (starting sample number 2797568), the 39plus will also erase Block 1.
4. This continues until the sample counter reaches the end of the memory.

If the 39plus/39plus-IM fills the 64 Mb memory, the entire first half of the memory (sample numbers 1 – 2796202) will be lost. The second half of the memory will always remain intact.

Sea-Bird has updated the 39plus and 39plus-IM firmware to eliminate this bug.

- SBE 39plus units must be upgraded to firmware version 4.3.2
- SBE 39plus-IM units must be upgraded to firmware version 4.5.2

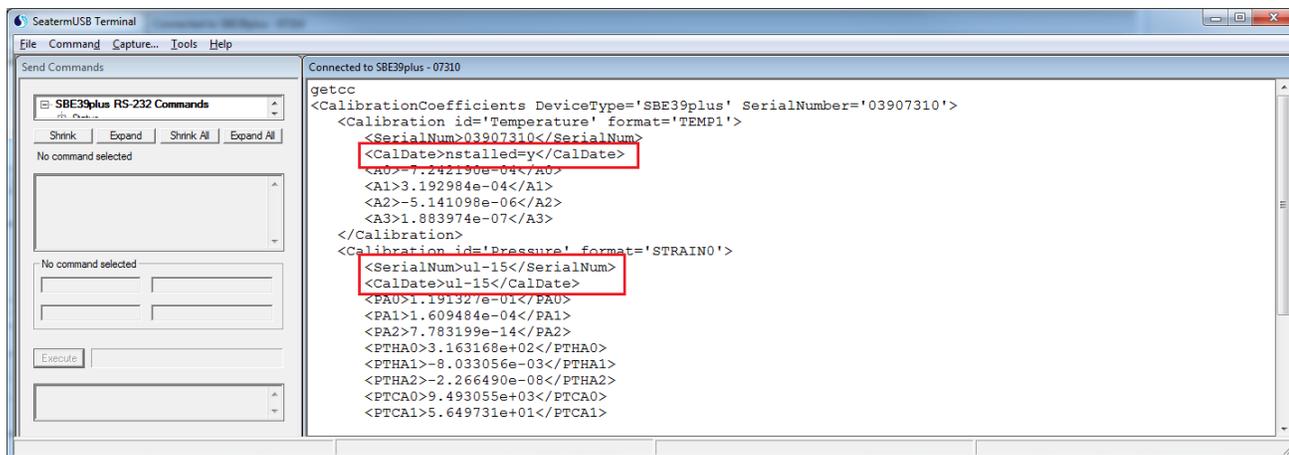
If the 39plus firmware version was below v4.3.0 prior to upgrading to v4.3.2, or the 39plus-IM firmware version was below v4.4.0, the firmware upgrade process will change the temperature and pressure calibration dates and the pressure sensor's serial number. The "GetCC" command shows this:

While not crucial for the instrument's operation, these can be easily fixed with a few commands. To change them back, connect your 39plus/39plus-IM to SeaTermV2, upload any necessary data from the memory, and send the following commands:

- Factorymode=1
- Tcaldate=dd-mmm-yy (example: Tcaldate=27-feb-18)
- Pcaldate= dd-mmm-yy (example: Pcaldate=27-feb-18)
- Psn= ##### (example: Psn=1234567)
 - This command must be sent twice, and will reset the memory
- GetCC
- Factorymode=0
