Troubleshooting Basics: Moored CTDs

Tips for Identifying and Addressing Common Problems

Greg Ikeda, November 2018

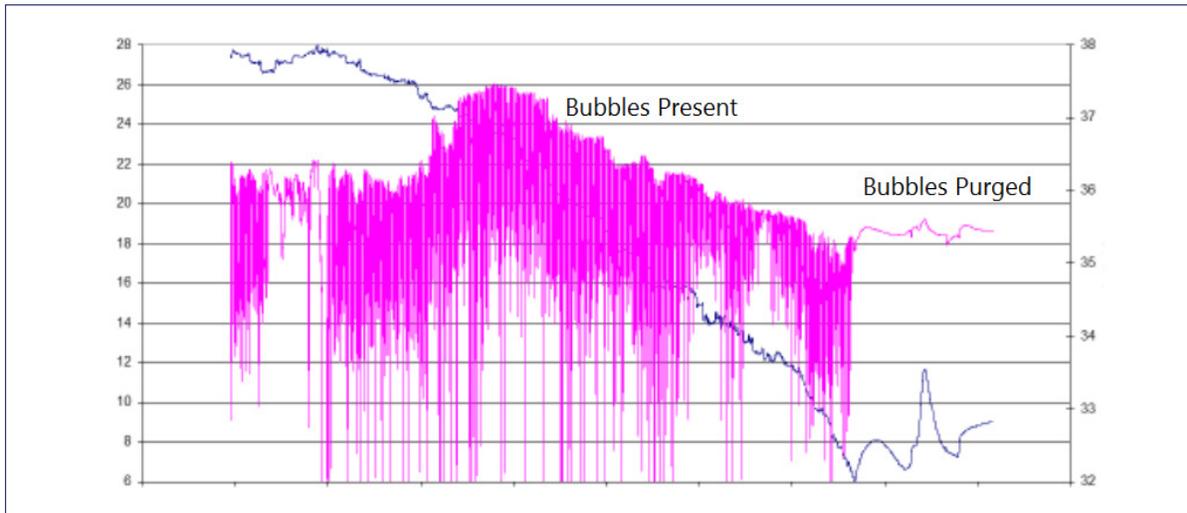
Bubbles in the conductivity cell can result when the flow path is clogged. These will generate downward spikes in the conductivity data. These spikes can look similar to electrical noise if large air bubbles are present in the plumbing.

- Spikes will always be towards low conductivity.
- Spikes often disappear at higher pressures or when the pump kicks in.
- Bubbles may be more common for CTDs deployed near the surface.
- This is true for both moored and profiling CTDs.

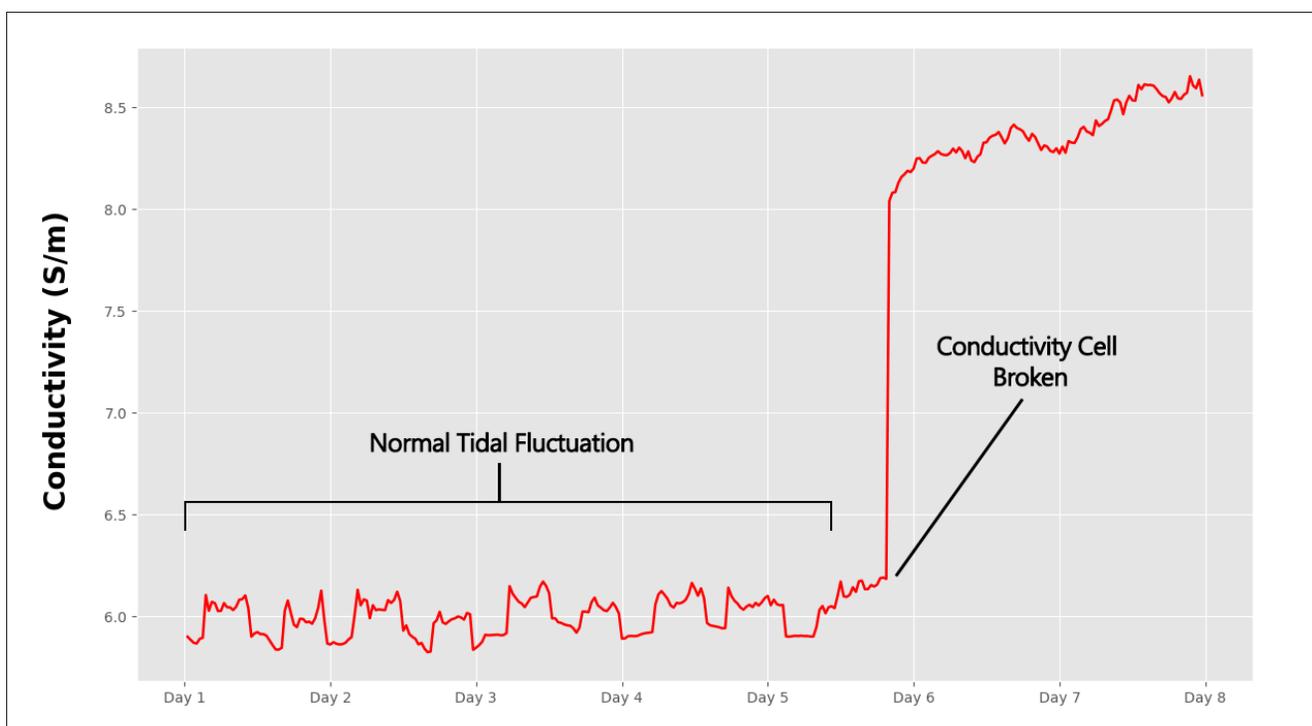
Sediment/material in the conductivity cell will be similar to bubbles, possibly persisting longer.

- Spikes will also be low of correct.
- Often forms a more "rounded off" spike, especially in high-sediment areas.

A broken conductivity cell will often form a single jump towards higher conductivity that stays constant or drifts gradually.

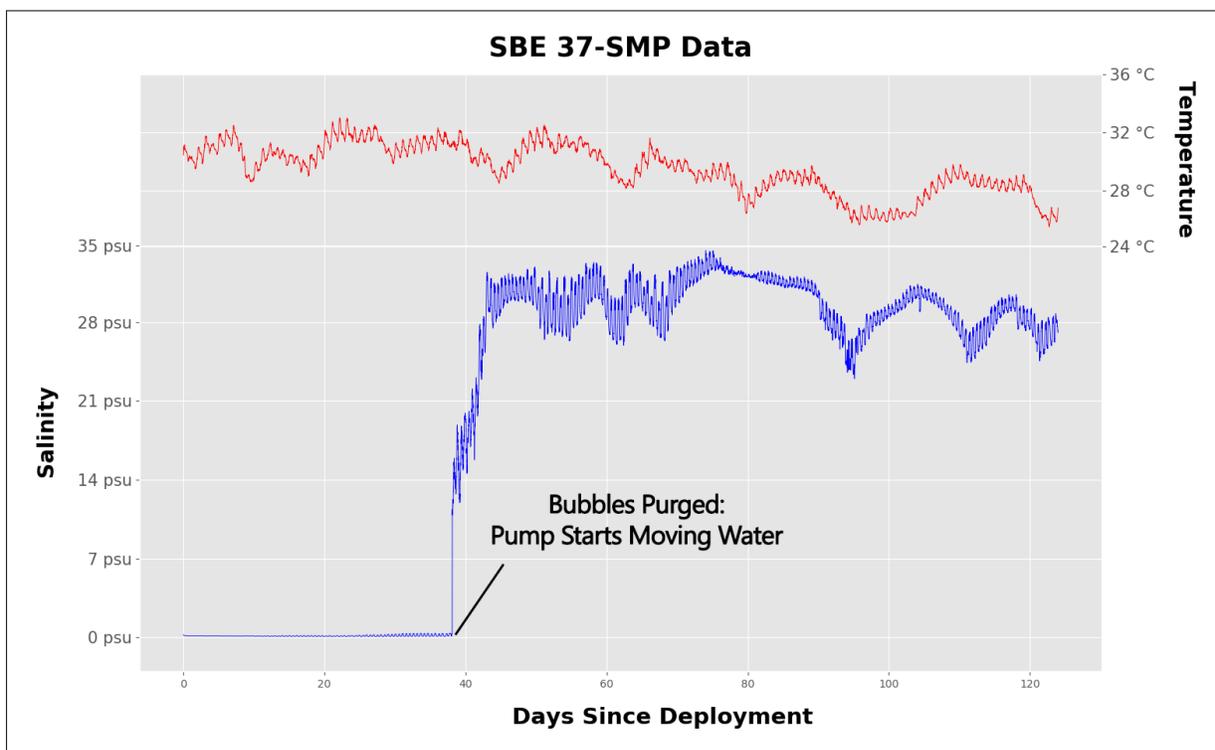
Sea-Bird pumps are not self priming; air bubbles must be purged before the pump is able to operate properly. Common reasons a pump will not start are because the pathway for air bubbles to escape is clogged. An unprimed pump is usually evident when viewing data: conductivity and salinity will often appear static relative to temperature, or will stay at a near-zero value until the pump turns on if large air bubbles are caught in the conductivity cell. Once bubbles are purged and the pump is able to flush water, conductivity and salinity will usually recover quickly.

- Deploy the CTD in an orientation that allows bubbles to escape—typically with the air bleed hole at the highest point
- Clear the air bleed hole on pumped CTDs regularly
- Flush the flow path regularly, especially in high-sediment environments
- Avoid deploying the CTD close to the surface on fixed marine moorings. At low tide, the sensor may be above the surface; bubbles may remain in the plumbing after resubmerging.

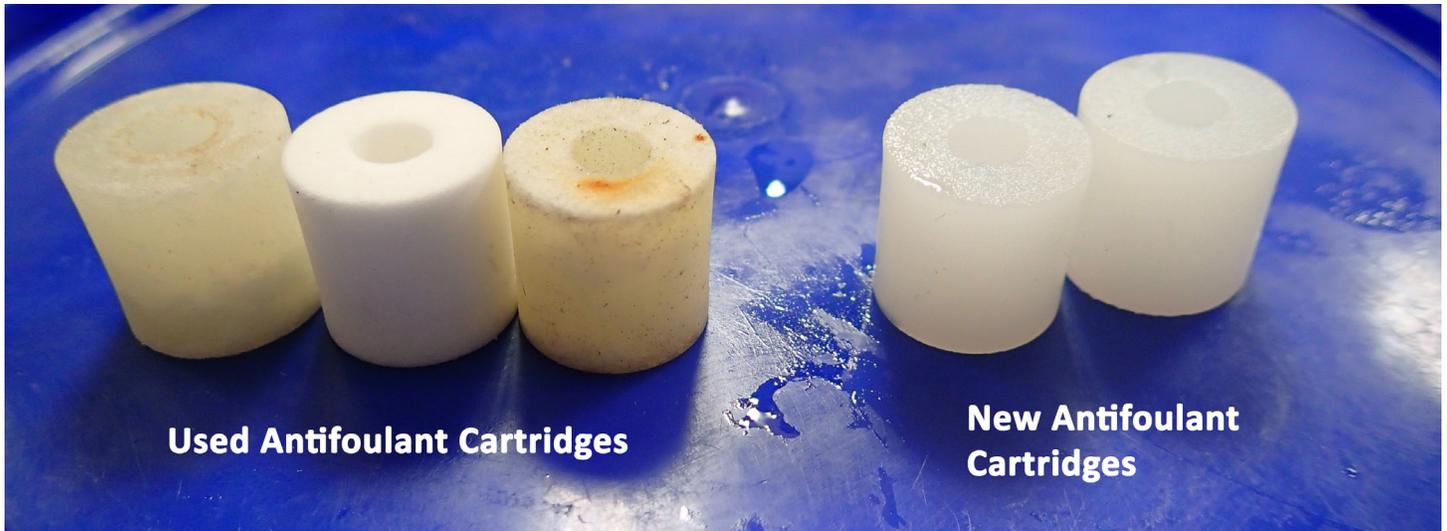
Two Bis(tributyltin) oxide (aka "TBTO") antifouling cartridges housed inside the CTD's plumbing prevent biofouling on the sensors connected to the flow path. These cartridges saturate the water inside of the plumbing to prevent biological growth between samples. Even when the housing becomes unrecognizable from biological growth, the flow path and conductivity cell should remain clear of fouling for the duration of the deployment. Whenever possible, it is best to remove and visually inspect the cartridges—spent cartridges will have a mottled or bleached appearance:

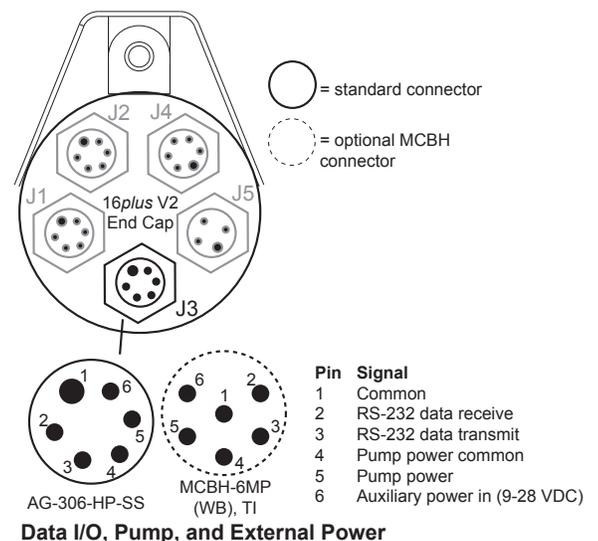
If a “stop” command was not manually sent to the CTD via a terminal, but the CTD indicates that logging stopped due to receipt of the “stop” command, moisture may have contacted the Data I/O connector. The resulting electrical noise can trigger a “stop” signal for the CTD, causing it to halt logging prematurely.

- Clean the connector pins with high-purity alcohol
- Clean and regrease the connector with DC4 Silicone insulating compound
- Clean and regrease all cables and dummy plugs
- Check for signs of damage or corrosion
- Inspect the bulkhead connector for chips, cracks, or other flaws that may compromise the seal
- Ensure the cable or dummy plug is securely connected before redeployment
