Frame Coating Repair for the SBE 32 Carousel Water Sampler

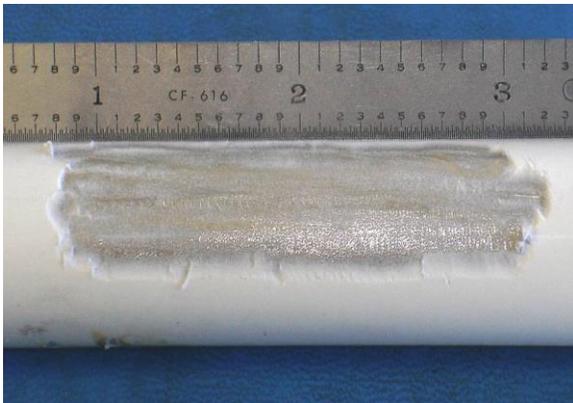
This procedure applies to larger areas of damage, where the coating has been severely scraped and removed from the part (see photo below).

Coating scraped from frame part;
damaged area approximately
2 inches (5 cm) long

1. Completely remove all loose coating material from the area to be repaired, using a metal file or sandpaper.
2. Sand any burrs or gouges in the aluminum to remove sharp edges.

3. Clean and degrease the exposed metal with a cellulose thinner or white spirit.
4. Heat the exposed metal using a heat gun or propane torch. **Do not allow a direct flame to contact the undamaged coating material;** direct contact will damage and discolor the material. Use the IR thermometer to monitor the temperature; a minimum temperature of 150 °C is required for the powder to adhere to the part. (In tests at Sea-Bird, it took approximately 15 minutes to heat the part to 150 °C with a heat gun).

5. Once the part has reached the required temperature, carefully apply the PPA 571ES powder to the part. Sprinkle the powder on evenly, in thin coats, using a small flour sifter. It is important to build the repair slowly, with thin coats of powder. Continue to maintain the heat on the part to allow the material to flow evenly. When enough powder has been added to fill in the damaged area, allow the part to cool.

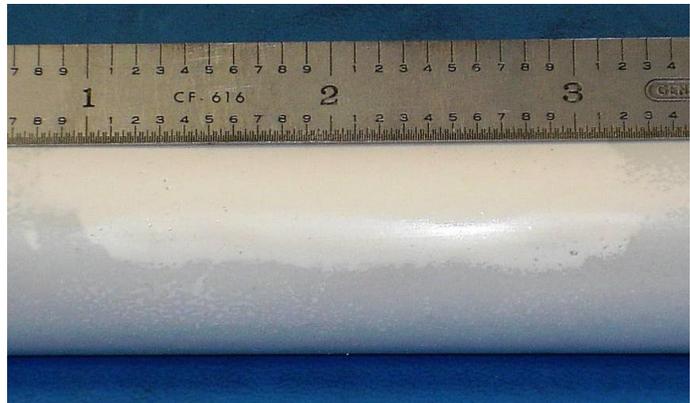
Repaired frame part.
Repair has been sanded and had heat applied to
restore *gloss* finish (steps 6A and 6B).

6. When cool, the new coating can be treated further to improve the appearance of the repair, if desired (these steps improve the appearance of the repair, but are **not required**):

- A. To match the contour of the surrounding coating, sand the new coating.
 - B. To restore the *gloss* to the coating, heat the repaired and sanded area with the heat gun.
