Troubleshooting Basics: Moored CTDs

Tips for Identifying and Addressing Common Problems

Greg Ikeda, November 2018

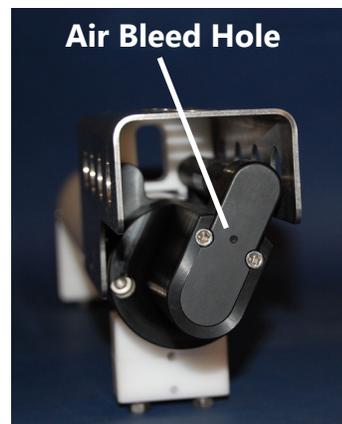
- Deploy the CTD in an orientation that allows bubbles to escape—typically with the air bleed hole at the highest point
- Clear the air bleed hole on pumped CTDs regularly
- Flush the flow path regularly, especially in high-sediment environments
- Avoid deploying the CTD close to the surface on fixed marine moorings. At low tide, the sensor may be above the surface; bubbles may remain in the plumbing after resubmerging.

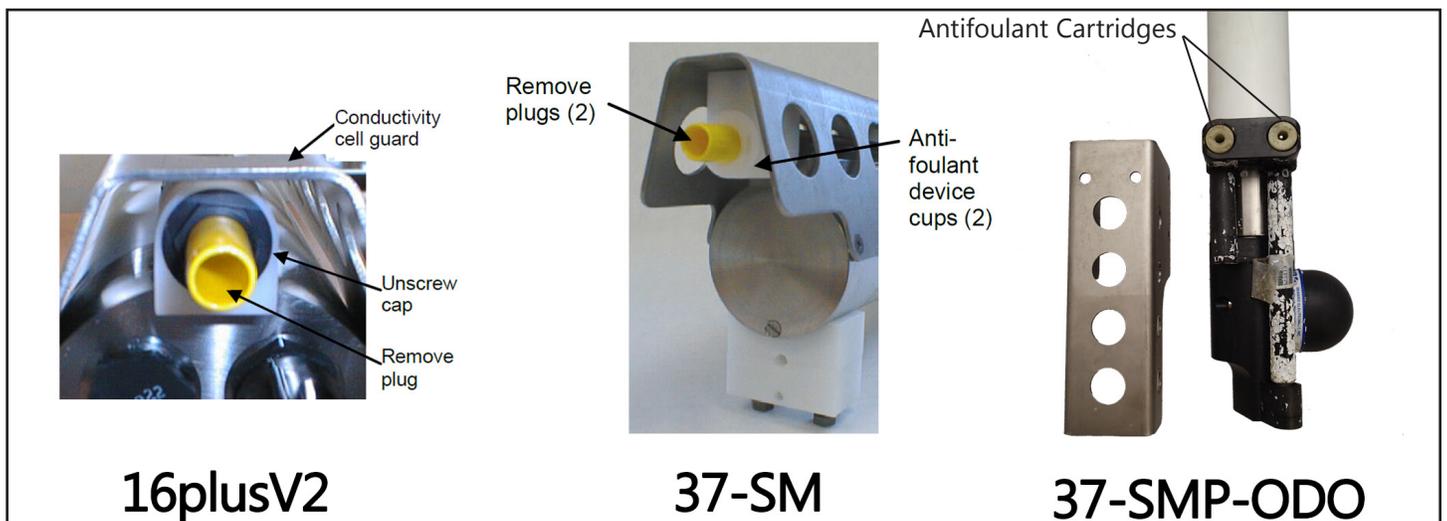
The lifespan of the TBTO cartridges is highly dependent on factors such as temperature, growth rates in the surrounding environment, and sampling regime. Therefore, estimating when to replace the TBTO cartridges is difficult. The locations of TBTO cartridges for common moored CTDs are below:
