Equipment Affected

This field service bulletin applies to **all SBE 56 Temperature Loggers with firmware versions 0.96, 0.97, 1.0, and 1.01**. This corresponds with any **SBE 56 with a serial number below 56-09381**.

Problem Description

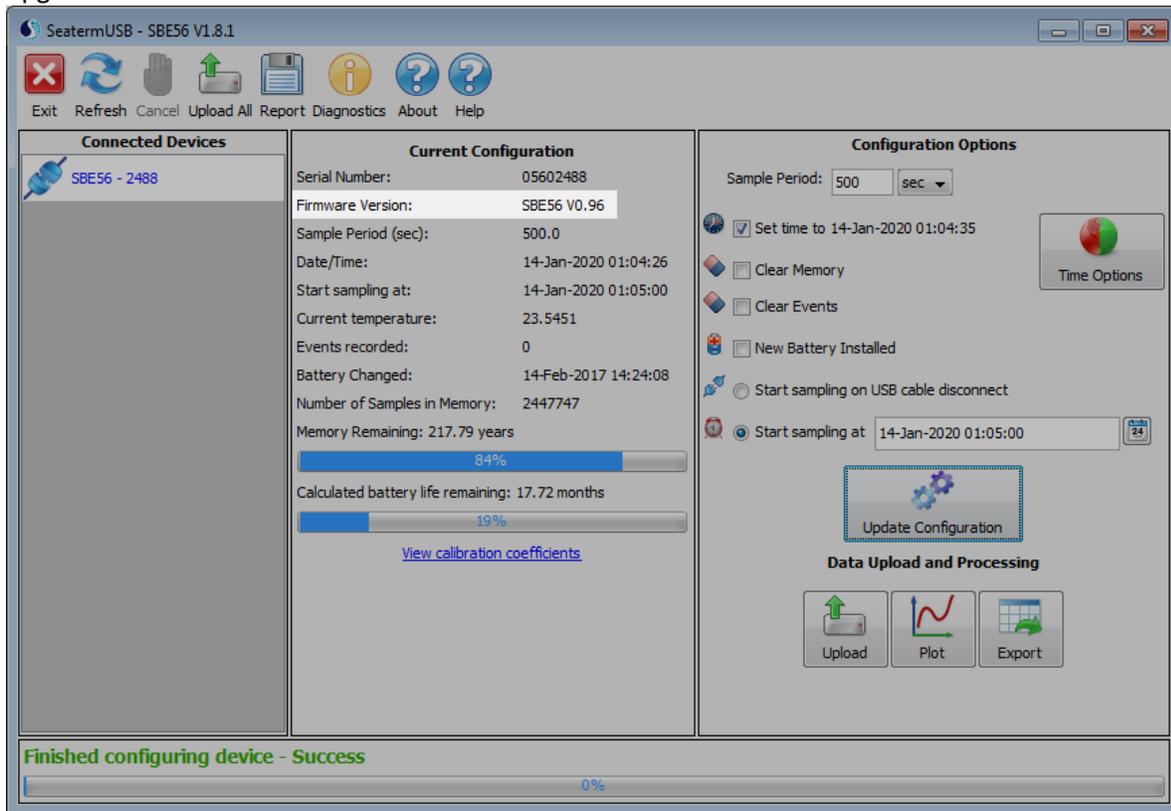
1. Connect the SBE 56 to SeatermUSB to determine the current firmware version. This will dictate which firmware upgrade to install:

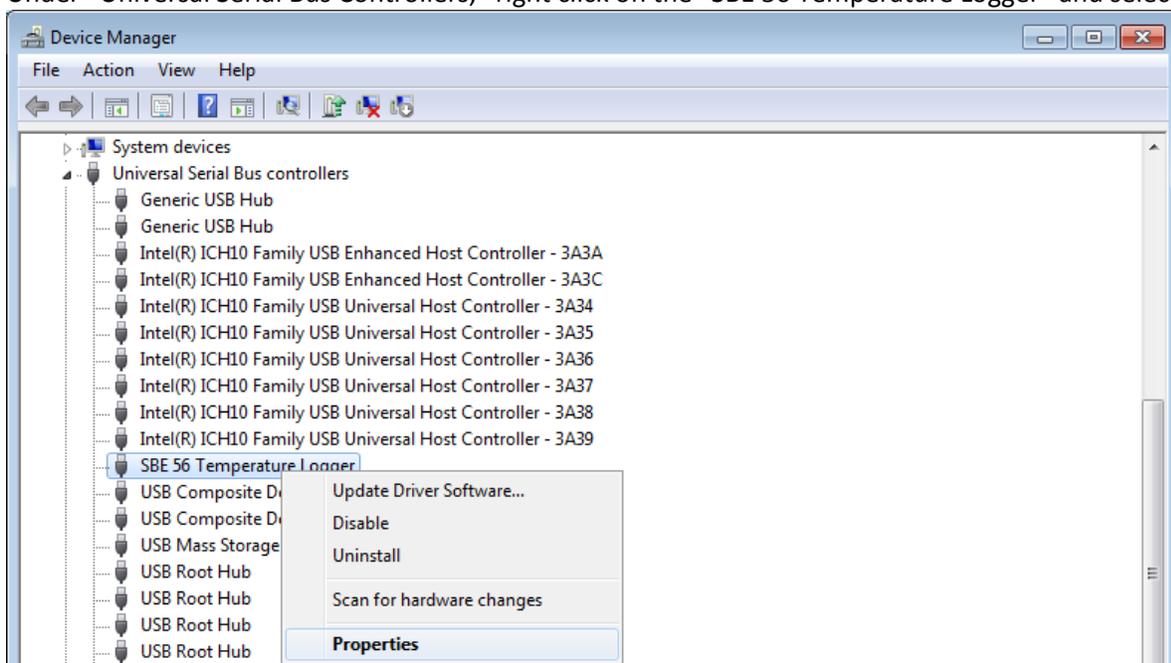
2. Close SeatermUSB.
3. Navigate to the Device Manager.
4. Under “Universal Serial Bus Controllers,” right click on the “SBE 56 Temperature Logger” and select “Properties”.

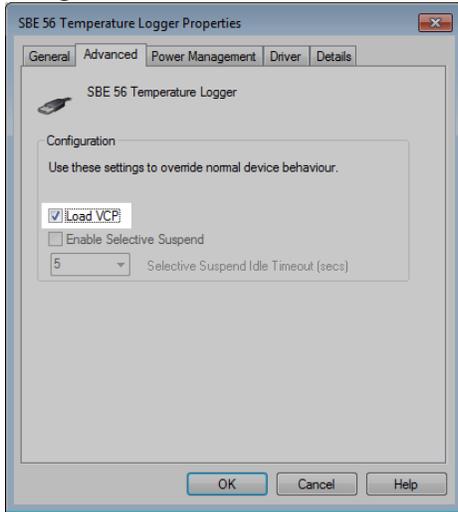
5. Navigate to the “Advanced” Tab and check “Load VCP”.

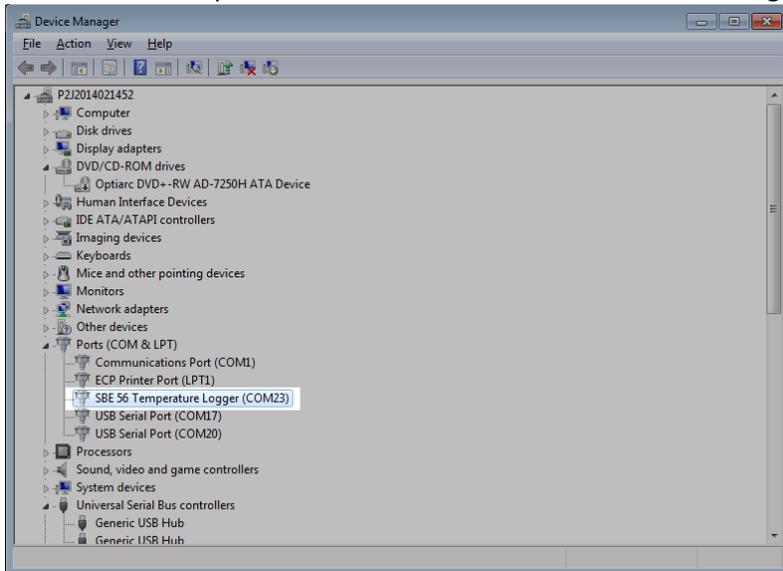
8. Locate the “SBE 56 Temperature Logger” under “Ports (COM & LPT)”. Determine the COM port # assigned to the SBE 56. The example below shows that this SBE 56 has been assigned to COM port 23:

Remember this number—this is the COM Port you will specify in the Firmware Loader.

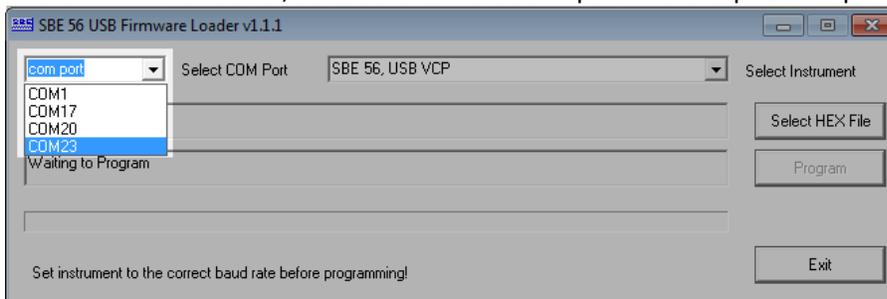
10. In the Firmware Loader, select the correct COM port in the top left dropdown box:

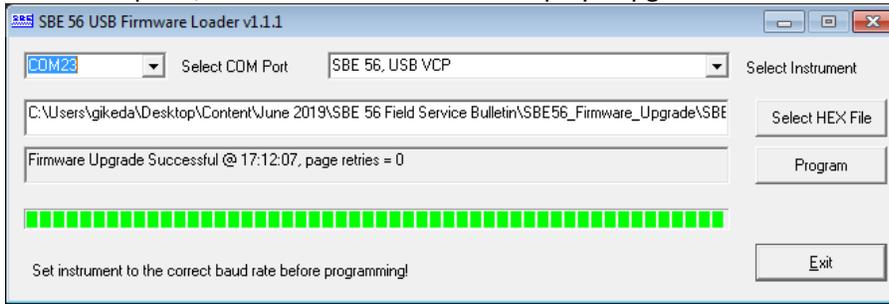
Note: if the incorrect firmware file is selected, the Firmware Loader will automatically prevent the update.
13. Click on “Program” and allow the Firmware Loader to complete the upgrade. **Do not disconnect the SBE 56 from the computer until complete.**
14. When complete, the Firmware Loader will display “Upgrade Successful”.

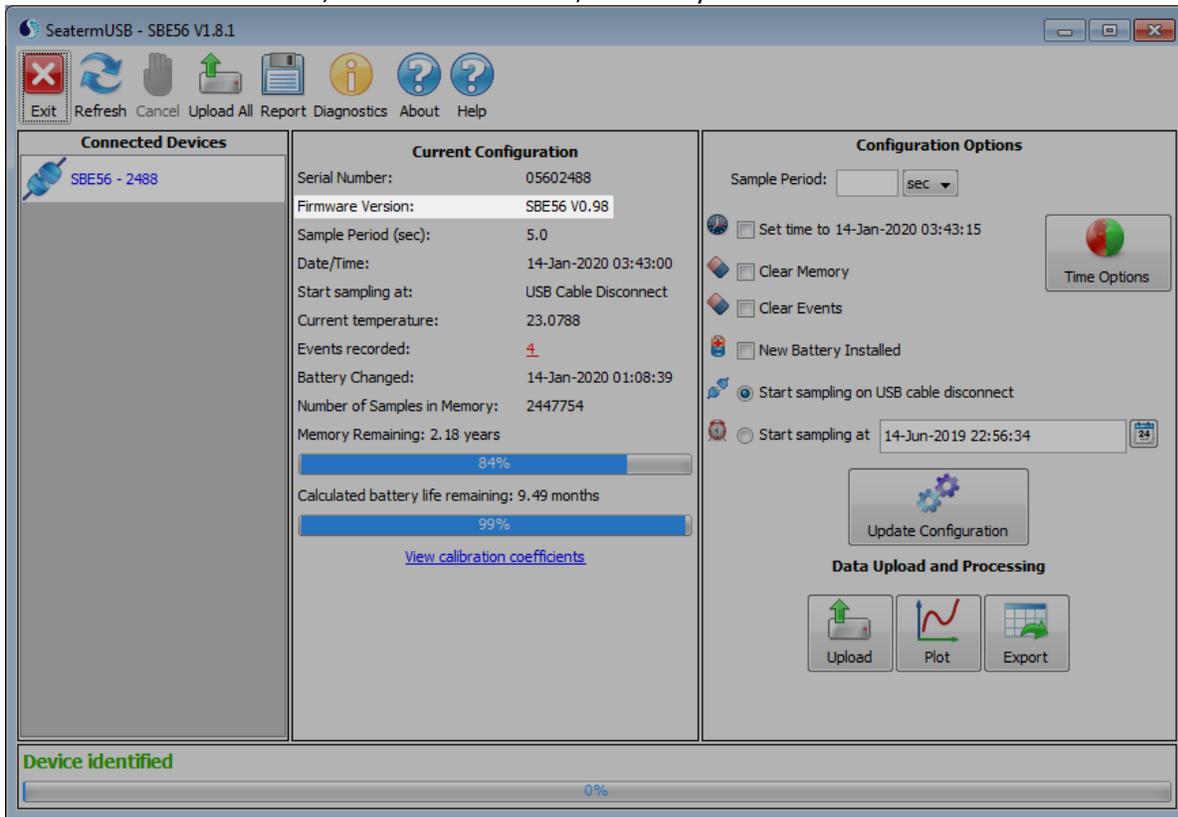
15. Close the Firmware Loader, Launch SeatermUSB, and verify the new firmware version:
