# Troubleshooting

Sea-Bird Scientific University Module 21

In this module we will discuss troubleshooting. Troubleshooting is an art based on a fundamental understanding of the way your equipment is supposed to work. We will attempt to cover the most common problems in this broad topic, ranging from problems with electronic circuits to mechanical parts that need to be cleaned.

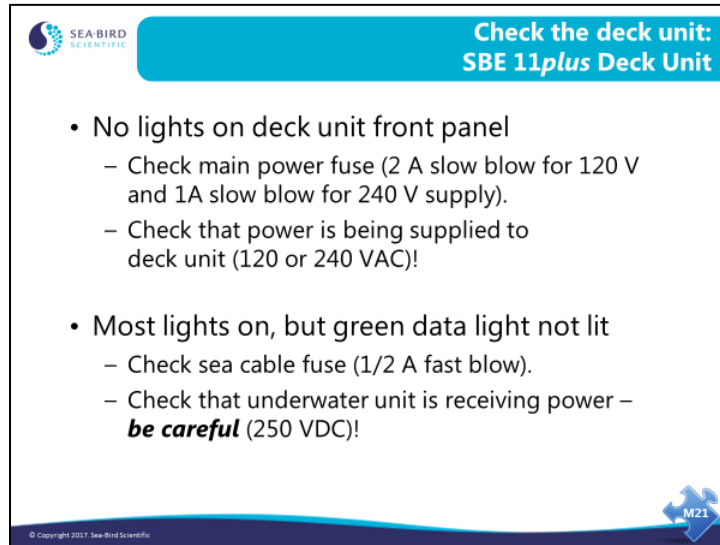
**Check the deck unit:  
SBE 11*plus* Deck Unit**

- No lights on deck unit front panel
  - Check main power fuse (2 A slow blow for 120 V and 1A slow blow for 240 V supply).
  - Check that power is being supplied to deck unit (120 or 240 VAC)!
- Most lights on, but green data light not lit
  - Check sea cable fuse (1/2 A fast blow).
  - Check that underwater unit is receiving power – ***be careful*** (250 VDC)!

After the obvious things, like checking the fuse and the power outlet the deck unit is plugged into, check that the underwater unit is receiving power. If you disconnect the sea cable underwater connector from the CTD, you should find a large DC voltage (150 – 250V) between the large pin and the small pin. Note that the large pin is ground.

Real-time systems that are running via an *Interface Box* or *Opto-Box* will have only 10 – 15 volts across the sea cable connector.

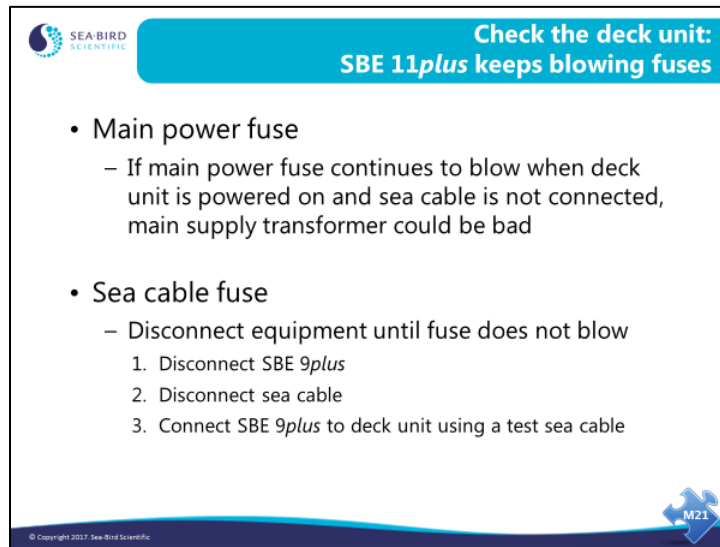
**Check the deck unit:  
SBE 11*plus* keeps blowing fuses**

- Main power fuse
  - If main power fuse continues to blow when deck unit is powered on and sea cable is not connected, main supply transformer could be bad
- Sea cable fuse
  - Disconnect equipment until fuse does not blow
    1. Disconnect SBE 9*plus*
    2. Disconnect sea cable
    3. Connect SBE 9*plus* to deck unit using a test sea cable

A bad main supply transformer is usually caused by installing a main power fuse with an incorrect rating **do not try to solve the problem of blowing the fuse by installing a bigger one!**

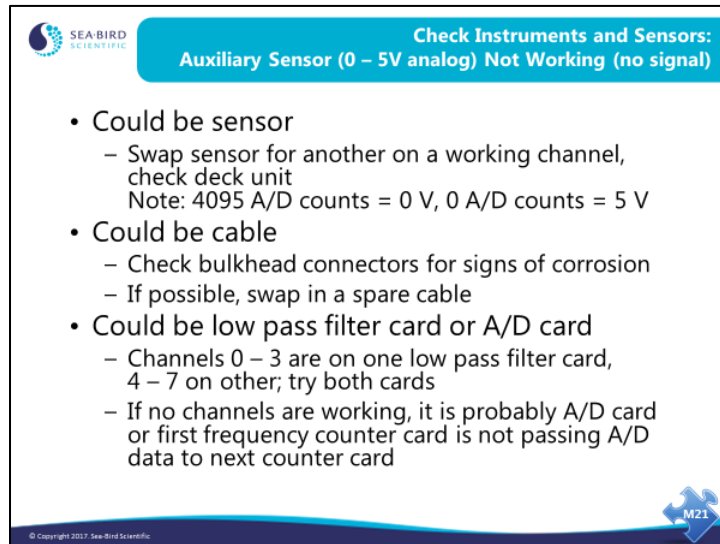
**Check Instruments and Sensors:  
Auxiliary Sensor (0 – 5V analog) Not Working (no signal)**

- Could be sensor
  - Swap sensor for another on a working channel, check deck unit
  - Note: 4095 A/D counts = 0 V, 0 A/D counts = 5 V
- Could be cable
  - Check bulkhead connectors for signs of corrosion
  - If possible, swap in a spare cable
- Could be low pass filter card or A/D card
  - Channels 0 – 3 are on one low pass filter card, 4 – 7 on other; try both cards
  - If no channels are working, it is probably A/D card or first frequency counter card is not passing A/D data to next counter card

The front end of the analog-to-digital system consists of 2 printed circuit boards with 4 channels on each. If you have problems in one channel, switch to the other analog input card. If the problem disappears, it is in the analog input PCB. If the problem persists, it may be in the analog-to-digital conversion PCB.

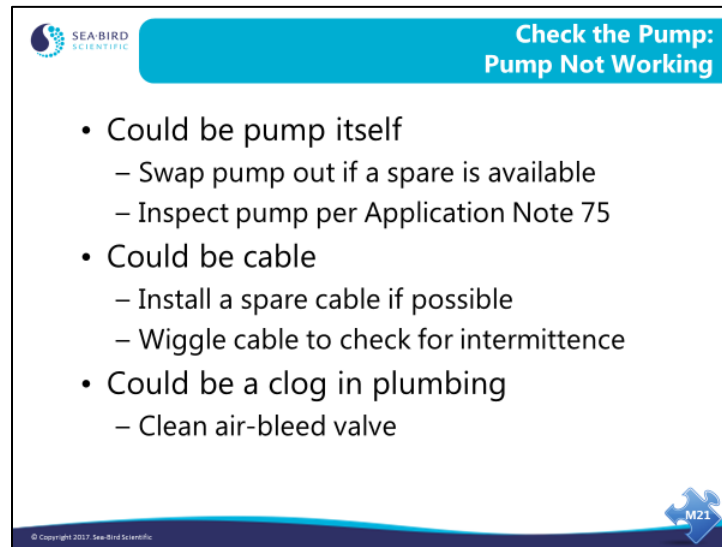
**Check the Pump:  
Pump Not Working**

- Could be pump itself
  - Swap pump out if a spare is available
  - Inspect pump per Application Note 75
- Could be cable
  - Install a spare cable if possible
  - Wiggle cable to check for intermittence
- Could be a clog in plumbing
  - Clean air-bleed valve

Symptoms of pump malfunction include:

- A big mismatch between downcast and upcast data. Even with a non-functioning pump, on the downcast some water is forced through the plumbing by the movement of the system through the water. However, on the upcast, the forcing of water through the plumbing is reduced.
- Large differences in data from primary and secondary T and C sensors for *9plus* with primary and optional secondary T and C sensors, indicating that one pump is malfunctioning.
- Erratic, undulating data.

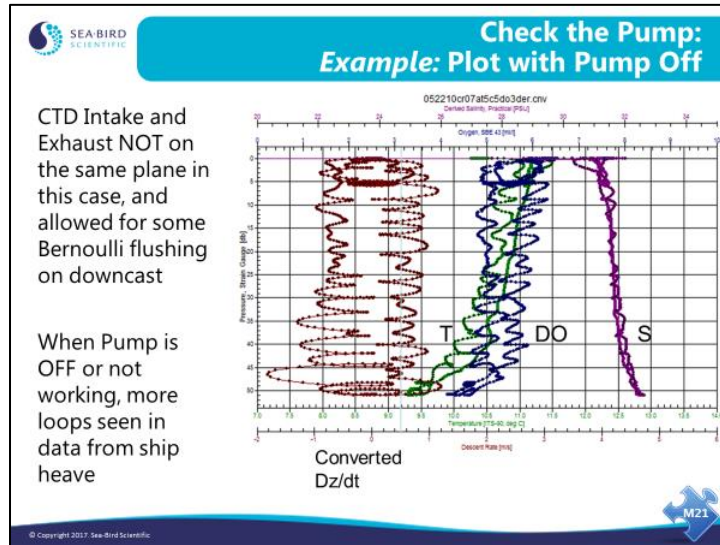
This allowed for some Bernoulli flushing on the down cast, which is why the downcast and upcast appear different.

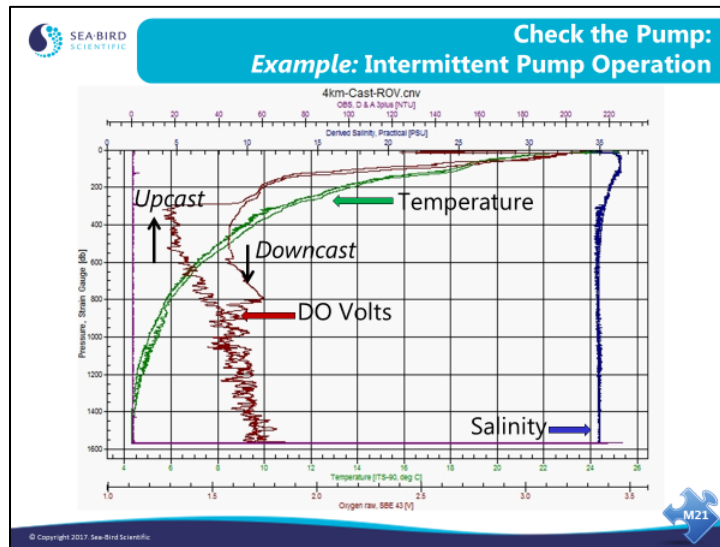
Notice that the upper 800 meters of DO looks fine... then it drops at around 800 m and is noisy and stays low...

Still noisy on upcast, then recovers around 350 m.

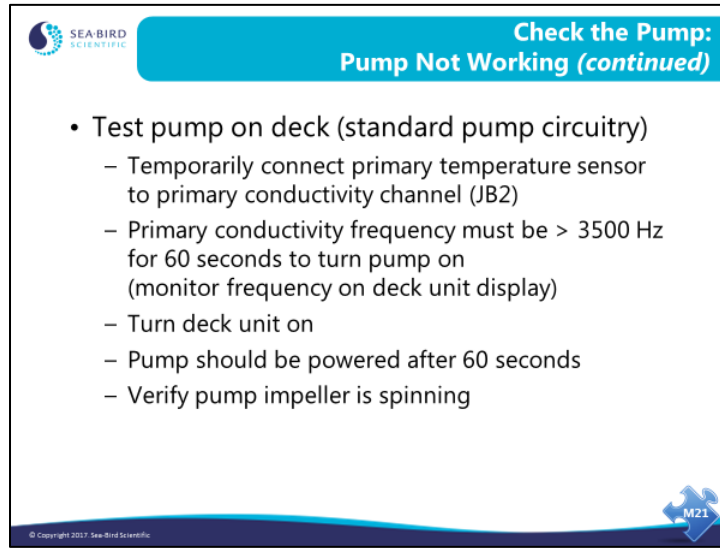
**Check the Pump:  
Pump Not Working (continued)**

- Test pump on deck (standard pump circuitry)
  - Temporarily connect primary temperature sensor to primary conductivity channel (JB2)
  - Primary conductivity frequency must be > 3500 Hz for 60 seconds to turn pump on (monitor frequency on deck unit display)
  - Turn deck unit on
  - Pump should be powered after 60 seconds
  - Verify pump impeller is spinning

To test a pump on a *9plus* with standard pump circuitry, we substitute a temperature sensor for the conductivity sensor. At temperatures above approximately 10 °C, the temperature sensor output is greater than the 3500 Hz required on the primary conductivity channel to turn on the pump.

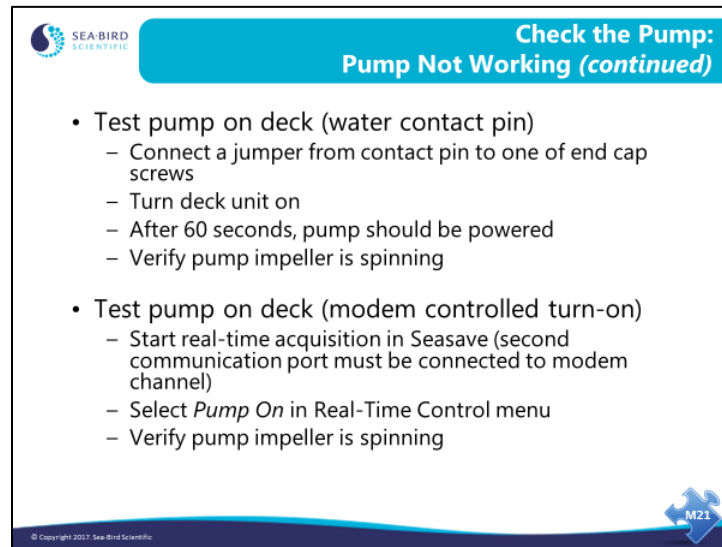
**Check the Pump:  
Pump Not Working (continued)**

- Test pump on deck (water contact pin)
  - Connect a jumper from contact pin to one of end cap screws
  - Turn deck unit on
  - After 60 seconds, pump should be powered
  - Verify pump impeller is spinning
- Test pump on deck (modem controlled turn-on)
  - Start real-time acquisition in Seasave (second communication port must be connected to modem channel)
  - Select *Pump On* in Real-Time Control menu
  - Verify pump impeller is spinning

The SBE *9plus* is available with custom modifications allowing pump turn-on to be independent of water conductivity, which can be useful for fresh water applications:

- Water contact pump control – This allows the pump to automatically turn on 60 seconds after a contact pin is immersed in water (salt **or** fresh), and automatically turn off when the contact pin is removed from the water. The contact pin is on a special dummy plug that connects to JB6 on the *9plus* bottom end cap; modifications to the *9plus* internal wiring to JB6 for this feature prevent use of JB6 for a bottom contact switch.

- Manual pump control This allows you to manually turn the pump on and off. Pump control commands are sent through the SBE *11plus* Deck Unit *Modem Channel* connector, but pump control does not interfere with water sampler operation. Seasave V7 supports this feature from within the user interface (enable/disable manual pump control on the Pump Control tab in the Configure Inputs dialog box; turn the pump on and off from the Real-Time Control menu). Earlier versions of Seasave supported this feature if the software was started with the *-pc* option from the command line.

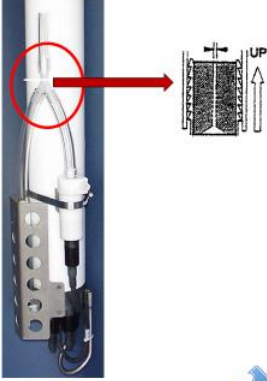
**Check the Plumbing:  
Air Purge Bleed Y-Valve**

- Check air bleed in Y-valve to be sure it is free of salt/sediment
  - Soak in warm soapy water
- Use 0.4 mm diameter wire (#26 AWG wire) to clean valve. Remove Tygon tubing above valve, and use needle-nosed pliers to force wire through hole
- Blow through valve to ensure it is open

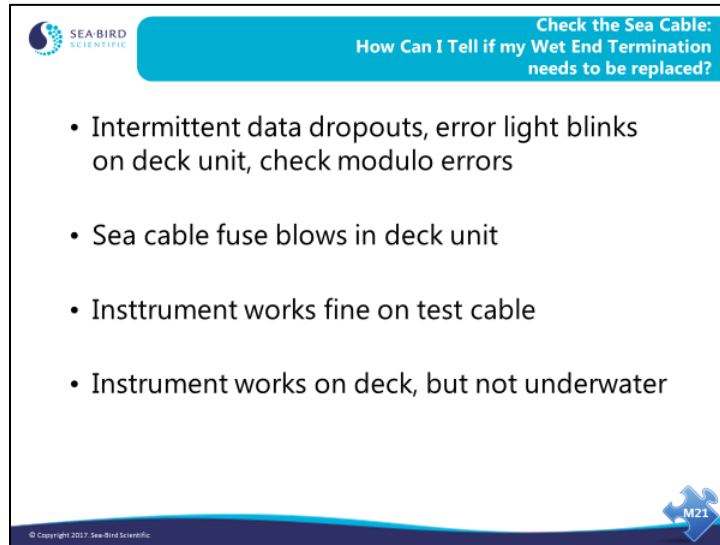
Check the Sea Cable:  
How Can I Tell if my Wet End Termination  
needs to be replaced?

- Intermittent data dropouts, error light blinks on deck unit, check modulo errors
- Sea cable fuse blows in deck unit
- Instrument works fine on test cable
- Instrument works on deck, but not underwater

The part of the sea cable that connects to the instrument package receives a lot of wear and is under a great deal of stress. The cross-sectional area of most instrument packages causes a huge load on the cable every time the ship rolls. The *9plus* data stream has an 8-bit counter that increments at each data scan, returning to 0 after 255. Missing scans show up as a missing number in the count. Because decoding the *9plus* counters requires a scan and the scan before it, missing scans show up as data spikes. Usually, data errors of this sort are caused by intermittent connection in the mating end of the sea cable.

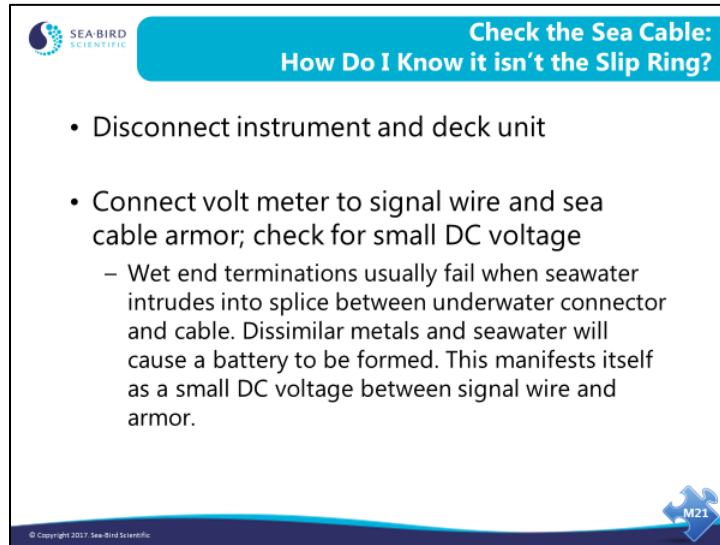
**Check the Sea Cable:  
How Do I Know it isn't the Slip Ring?**

- Disconnect instrument and deck unit
- Connect volt meter to signal wire and sea cable armor; check for small DC voltage
  - Wet end terminations usually fail when seawater intrudes into splice between underwater connector and cable. Dissimilar metals and seawater will cause a battery to be formed. This manifests itself as a small DC voltage between signal wire and armor.

Like other troubleshooting activities, the solution here is *divide and conquer*. Check the sea cable as described above. If everything seems normal, disconnect the slip-ring from the sea cable and the cabling that runs into the computer room. The slip-ring should present very low resistance on all of its conductors through a whole rotation. Switch to another conductor if you find one that has high resistance or becomes intermittent.

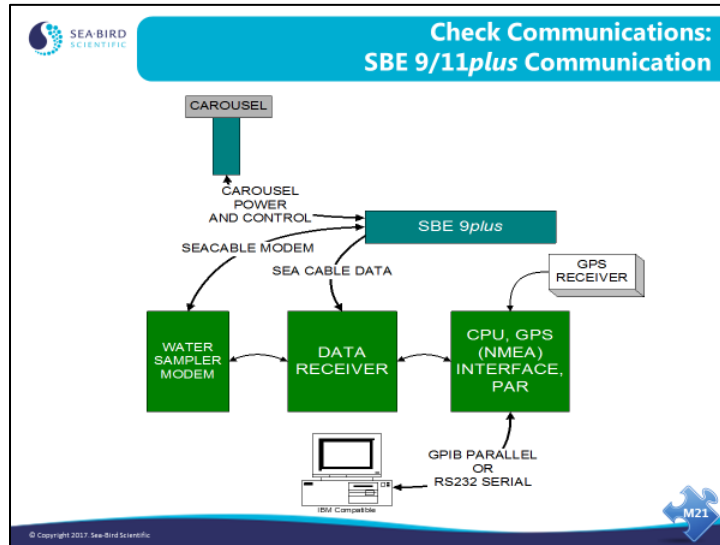
Here is a signal flow diagram for the circuit boards in the 11plus, the 9plus, the Carousel, and your PC. Note that water sampler commands pass from your computer to the 11plus CPU board, to the receiver board, to the modem board, to the 9plus, and into the Carousel.

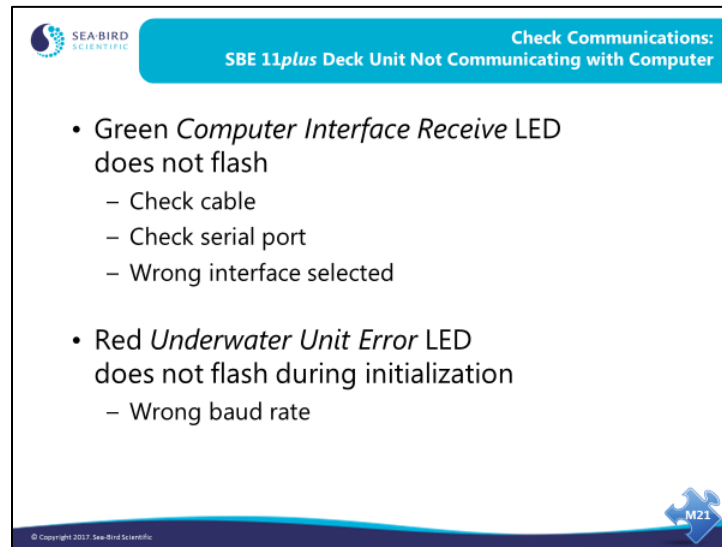
Check Communications:  
SBE 11plus Deck Unit Not Communicating with Computer

In considering the deck unit end of the system, first look to the cabling between the PC and 11*plus*. When Seasave starts, it communicates setup information to the 11*plus*. This data transmission causes the 11*plus* *Computer Interface Receive* LED to flash. If the 11*plus* is correctly receiving the setup information, the computer interface red *Underwater Unit Error* light will flash briefly during this time. If the red *Underwater Unit Error* LED does not flash, the baud rate is not correctly set. Check the Comm port setup on the Serial Ports tab in Configure Inputs in *Seasave*.

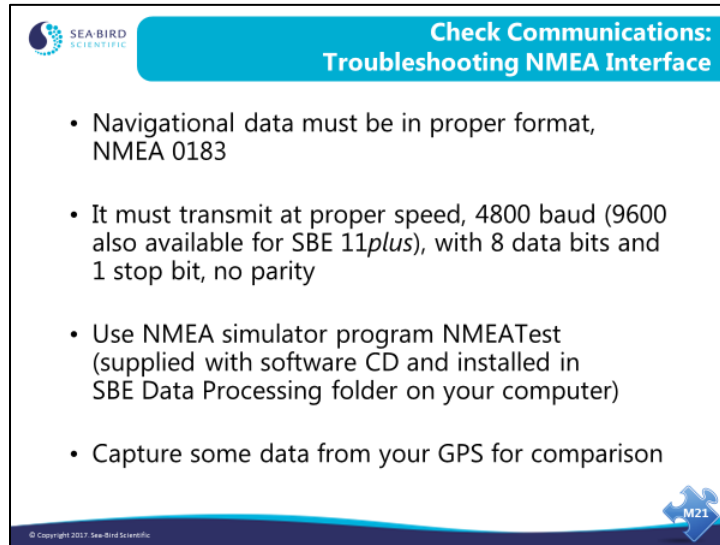
- Navigational data must be in proper format, NMEA 0183
- It must transmit at proper speed, 4800 baud (9600 also available for SBE 11*plus*), with 8 data bits and 1 stop bit, no parity
- Use NMEA simulator program NMEATest (supplied with software CD and installed in SBE Data Processing folder on your computer)
- Capture some data from your GPS for comparison

Adding navigational information to your data can be troublesome. Manufacturers of GPS receivers are not scrupulous in following the NMEA data format. You can check the transmit rate, data bits, and parity as well as output format of your GPS with your PC and a terminal program. If these do not match the NMEA standard, then you may not get latitude and longitude appended to your data. If you think that there is a problem with the deck unit receiving data, you can use your PC and the simulation program found in Seasoft. NMEA and GPS installation and troubleshooting is discussed in detail in the deck unit(s) manual.

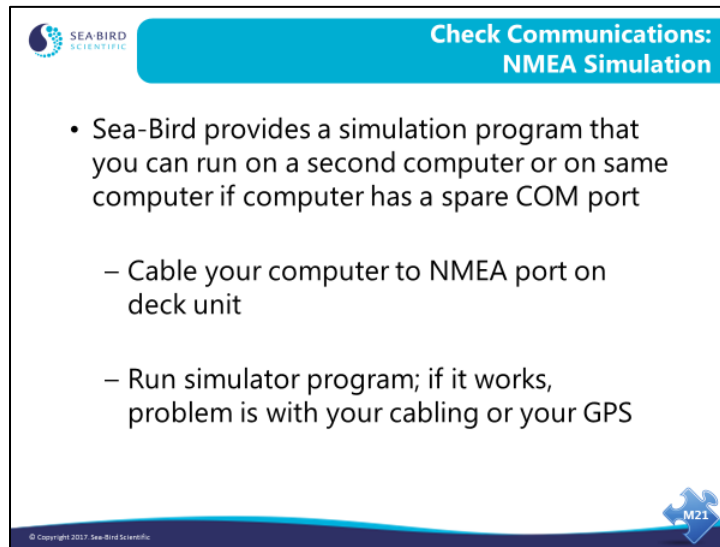
- Sea-Bird provides a simulation program that you can run on a second computer or on same computer if computer has a spare COM port
  - Cable your computer to NMEA port on deck unit
  - Run simulator program; if it works, problem is with your cabling or your GPS

You can test the deck unit and Seasave with the NMEA simulation program, NMEATest. Cable the NMEA port on the deck unit to a second PC with the provided cable. Alternatively, you can run the simulation using only one computer if the computer has a spare COM port. The simulation program sends NMEA messages in the RMA, RMC, GGA, or GLL format.

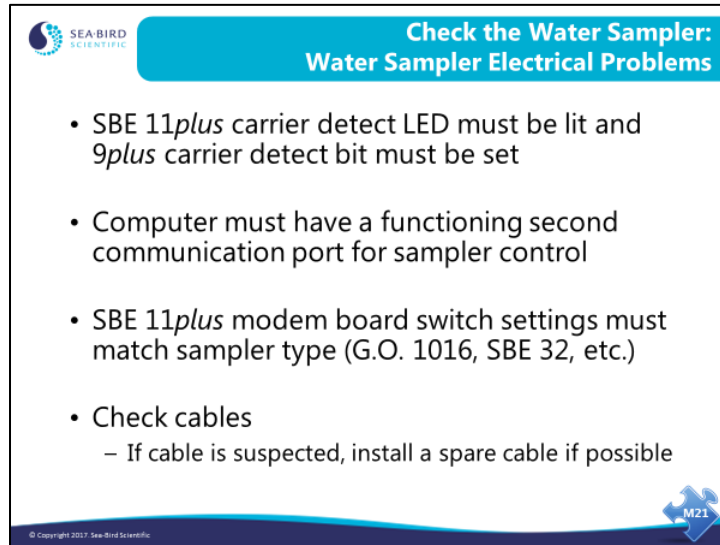
**Check the Water Sampler:  
Water Sampler Electrical Problems**

- SBE 11*plus* carrier detect LED must be lit and 9*plus* carrier detect bit must be set
- Computer must have a functioning second communication port for sampler control
- SBE 11*plus* modem board switch settings must match sampler type (G.O. 1016, SBE 32, etc.)
- Check cables
  - If cable is suspected, install a spare cable if possible

Water sampler control is carried out over a 300-baud modem channel. This channel is full duplex (both up and down communication) and shares the wire with the main data channel. Indications that the 9/11*plus* system has proper modem communication are found on the front panel of the 11*plus* and in the status bits of the 9*plus*. If the 11*plus* modem carrier frequency is detected in the 9*plus*, a status bit is set. If the 9*plus* carrier frequency is detected in the 11*plus*, a carrier LED is lit. For the SBE 33 Carousel deck unit, an LED flashes when communication is received from the SBE 32 Carousel or SBE 55 ECO.

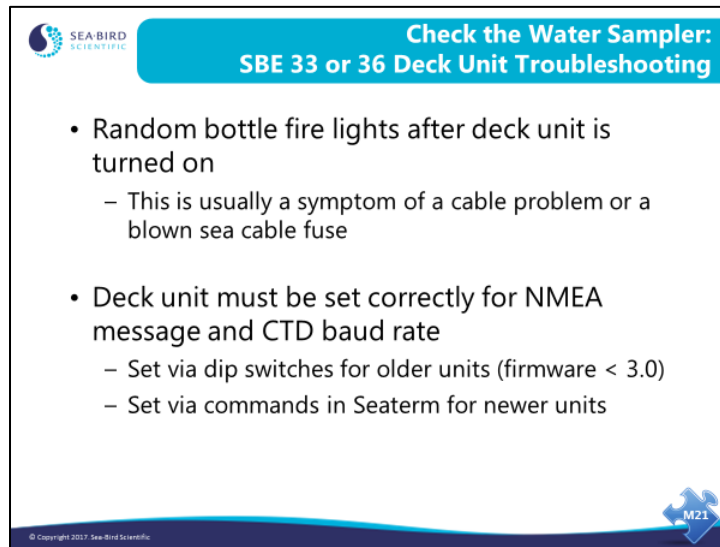
- Random bottle fire lights after deck unit is turned on
  - This is usually a symptom of a cable problem or a blown sea cable fuse
- Deck unit must be set correctly for NMEA message and CTD baud rate
  - Set via dip switches for older units (firmware < 3.0)
  - Set via commands in Seaterm for newer units

Use the same procedure to isolate the cause of a blown sea cable fuse as we discussed for the SBE 11*plus* deck unit: disconnect equipment until the fuse does not blow.

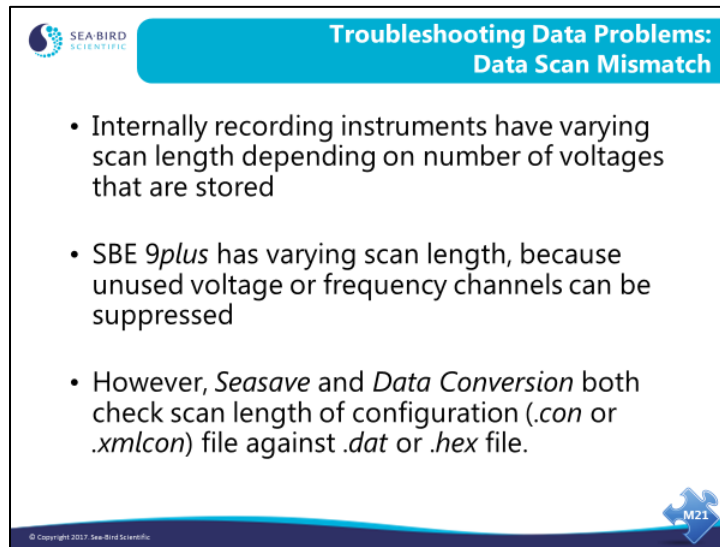
- Internally recording instruments have varying scan length depending on number of voltages that are stored
- SBE *9plus* has varying scan length, because unused voltage or frequency channels can be suppressed
- However, *Seasave* and *Data Conversion* both check scan length of configuration (.con or .xmlcon) file against .dat or .hex file.

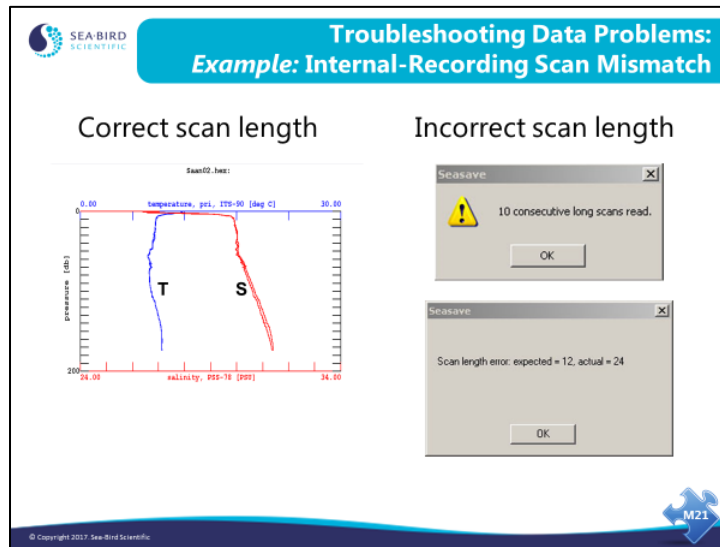
## Troubleshooting: Data Problems (*continued*)

To check for incompatibility between the data file and the .xmlcon or .con file, it is always a good idea to select *Options -> Check Scan Length* in Seasave.

You can only harm yourself with data scan mismatch with internally recording instruments. It is always good idea to take a look at your data before you initialize (erase) the memory in your internally recording CTD.
