Maintaining SBE 5T, 5P, and 5M Submersible Pumps

This application covers all SBE 5 pumps:

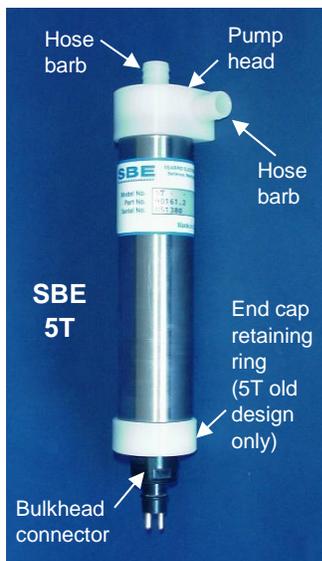
Note: White pump head was replaced with black pump head for SBE 5M, 5P, and 5T in November 2015; dimensions and functionality are identical.

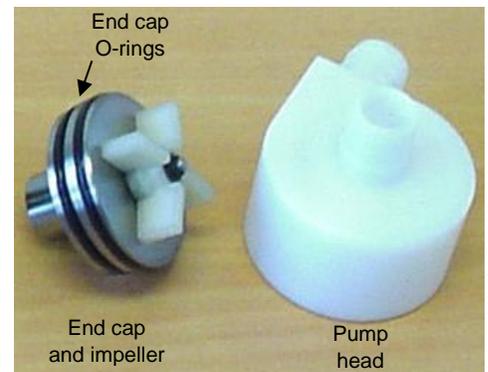
1. Unscrew the pump head from the housing.
2. Pull out the end cap from the housing.
3. Using clean, fresh water, thoroughly rinse the pump head and impeller.

4. Inspect the impeller for salt deposits. Clean any deposits with clean, fresh water and a toothbrush. Verify that the impeller can turn freely.
5. Inspect the shaft, and the O-ring and thrust washer holding the impeller on the shaft. There is another thrust washer underneath the impeller magnet, inside the housing. If this thrust washer is in good condition, you should observe a small gap between the bottom of the impeller and the end cap. If there is no gap, the thrust washer is worn and needs to be replaced (see *Annual Maintenance* for replacement procedure).

Remove the end cap and impeller from the housing before cleaning the impeller. The end cap O-rings seal the electronics chamber. The end cap may “walk” out of the housing after the pump head is removed, allowing water to enter the electronics chamber if you clean the impeller without first removing the end cap from the housing.

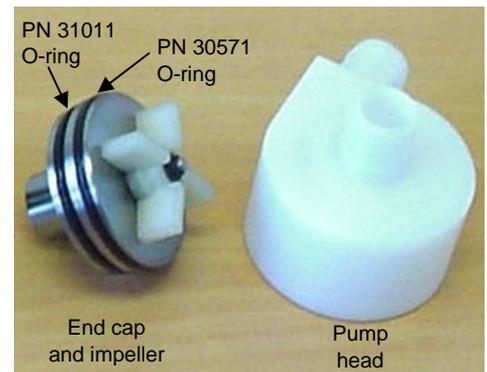
1. Unscrew the pump head from the housing.
2. Pull out the end cap from the housing.
3. Replace the O-ring and two thrust washers on the shaft:
 - A. Remove the O-ring from the shaft. A pair of tweezers works well for this.

- B. Pull the impeller and attached magnet off the shaft. The thrust washer above the impeller will come off at the same time. Inspect the impeller for salt build-up, and clean if necessary. Inspect the magnet for wear. Particularly in sandy coastal environments, the magnet may be worn down from abrasion. If necessary, replace the impeller / magnet assembly (PN 30009 or 234553).
Note: PN 30009 (with white impeller, as shown in photo) was replaced by PN 234553 (with black impeller) in 2012. These parts are interchangeable.

- C. Remove the second thrust washer from the bottom of the shaft. A pair of tweezers works well for this.
 - D. Inspect the shaft for wear.
 - E. Rinse the shaft and depression in the housing with clean, fresh water. Allow to dry.

- F. Using new thrust washers (2 of PN 30010) and O-ring (PN 30095), replace the thrust washer and impeller / magnet on the shaft. Replace the other thrust washer and O-ring on the shaft, above the impeller, pushing hard with your fingertip to seat the thrust washer and O-ring in place.

Remove the end cap and impeller from the housing before cleaning the impeller. The end cap O-rings seal the electronics chamber. The end cap may “walk” out of the housing after the pump head is removed, allowing water to enter the electronics chamber if you clean the impeller without first removing the end cap from the housing.

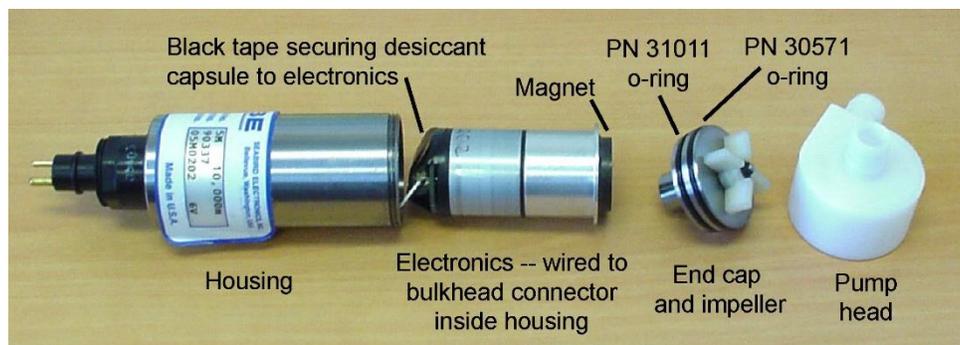
SBE 5M with Electronics Removed (titanium version shown; plastic version similar)

1. Unscrew the pump head from the housing.
2. Pull out the end cap from the housing.
3. Pull out the electronics from the housing. Note that the electronics are wired to the bulkhead connector inside the housing.

4. Verify that the magnet can spin freely and is not broken or damaged.
5. Look for other signs of damage on the electronics.
6. Reinstall the end cap in the housing:

- A. Apply a light coat of O-ring lubricant (Parker Super O Lube) to the O-ring and mating surfaces.
 - SBE 5M** – Gently place a **new desiccant capsule** (PN 31044 – 0.4 gram) on the electronics, and replace the black tape to secure it in place.

- B. Reinstall the electronics in the housing.
 - C. Reinstall the end cap in the housing, carefully aligning the end cap with the housing and pushing hard on the end cap to seat the first O-ring in the housing (only one O-ring should now be visible).

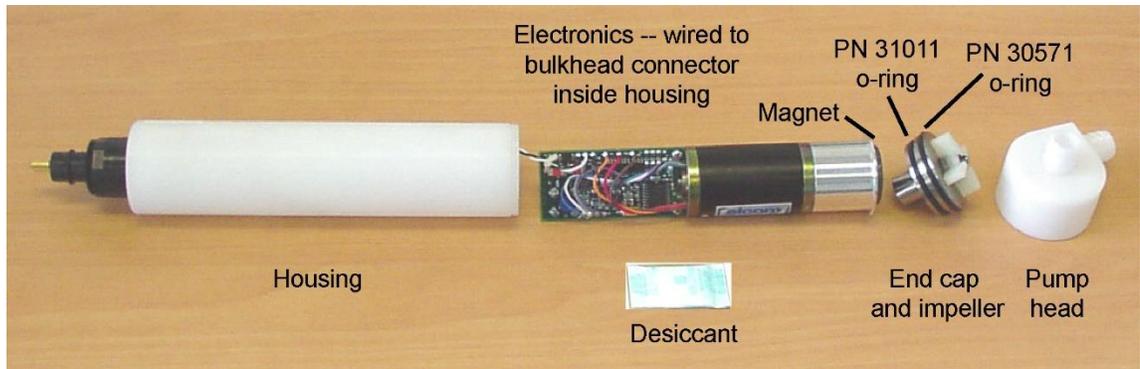
SBE 5P with Electronics Removed (5T similar)

- SBE 5P or 5T** - Gently place a **new desiccant bag** (PN 30558 – 1 gram) on the electronics. (see *Application Note 71* for desiccant use and regeneration).

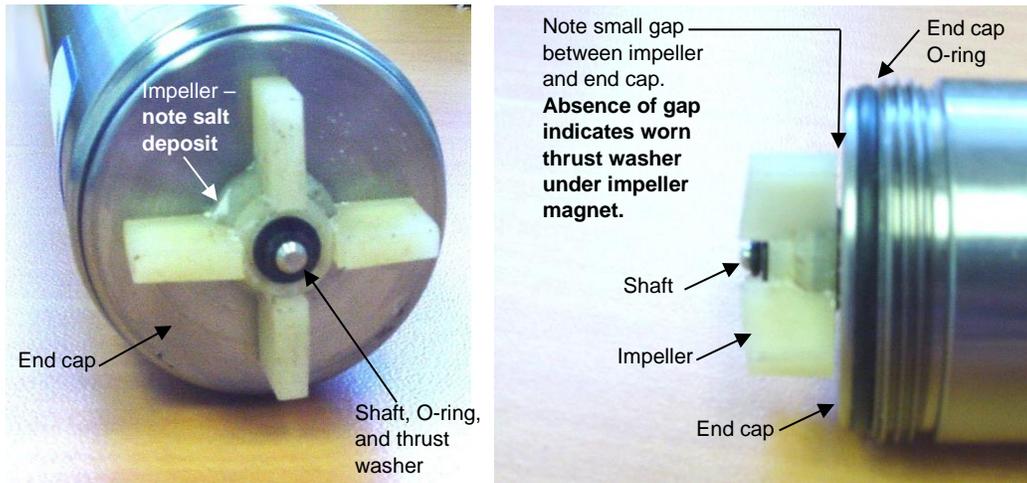
SBE 5T with Pump Head Removed

1. Unscrew the pump head from the housing.
2. Using clean, fresh water, thoroughly rinse the pump head and impeller.
3. Inspect the impeller for salt deposits. Clean any deposits with clean, fresh water and a toothbrush. Verify that the impeller can turn freely.
4. Inspect the shaft, and the O-ring and thrust washer holding the impeller on the shaft. There is another thrust washer underneath the impeller magnet, inside the housing. If this thrust washer is in good condition, you should observe a small gap between the bottom of the impeller and the end cap. If there is no gap, the thrust washer is worn and needs to be replaced (see *Annual Maintenance for SBE 5T* for replacement procedure).

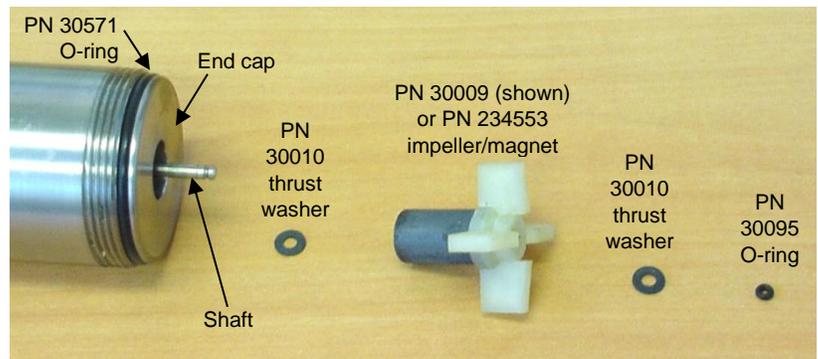
SBE 5T with Pump Head and Impeller Removed

1. Unscrew the pump head from the housing.
2. Replace the O-ring and two thrust washers on the shaft:
 - A. Remove the O-ring from the shaft. A pair of tweezers works well for this.

- B. Pull the impeller and attached magnet off the shaft. The thrust washer above the impeller will come off at the same time. Inspect the impeller for salt build-up, and clean if necessary. Inspect the magnet for wear. Particularly in sandy coastal environments, the magnet may be worn down from abrasion. If necessary, replace the impeller / magnet assembly (PN 30009 or 234553).
 Note: PN 30009 (with white impeller, as shown in photo) was replaced by PN 234553 (with black impeller) in 2012. These parts are interchangeable.

- C. Remove the second thrust washer from the bottom of the shaft. A pair of tweezers works well for this.
 - D. Inspect the shaft for wear.
 - E. Rinse the shaft and depression in the housing with clean, fresh water. Allow to dry.

- F. Using new thrust washers (2 of PN 30010) and O-ring (PN 30095), replace the thrust washer and impeller / magnet on the shaft. Replace the other thrust washer and O-ring on the shaft, above the impeller, pushing hard with your fingertip to seat the thrust washer and O-ring in place.

3. Inspect the end cap O-ring and the mating surface on the pump head for dirt, nicks, and cuts. Clean or replace as necessary. Apply a light coat of Parker Super O Lube to the O-ring and mating surfaces.

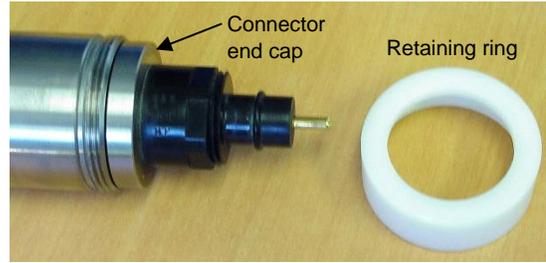
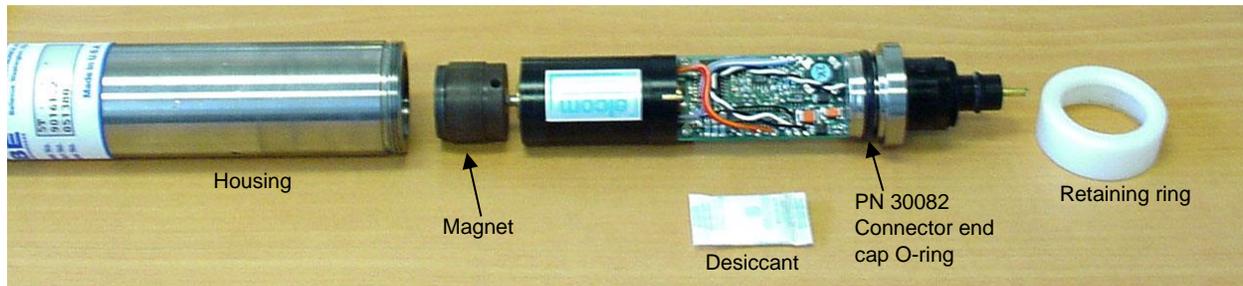
1. Unscrew the connector end cap retaining ring. Install a 2-pin dummy plug with locking sleeve over the bulkhead connector to provide a good grip and protect the connector pins. Rotate the end cap back and forth while carefully pulling the end cap away from the housing. Pull out the end cap and attached electronics from the housing.

2. Verify that the magnet can spin freely and is not broken or damaged.
3. Look for other signs of damage on the electronics.
4. Inspect the connector end cap O-ring and the mating surface in the housing for dirt, nicks, and cuts. Clean as necessary. If the O-ring or mating surface is damaged, return the pump to Sea-Bird for repairs.

5. Apply a light coat of Parker Super O Lube lubricant to the O-ring and mating surfaces. Gently place a **new desiccant bag** (PN 30558 – 1 gram) on the electronics (see *Application Note 71* for desiccant use and regeneration). Reinstall the electronics in the housing, until the O-ring has fully seated. Reinstall the retaining ring on the connector end cap.
